**June 29, 2009 Incident Review**  
**Dallas Fort Worth Data Center**  
**Review Dated: July 8, 2009**

The purpose of this document is to capture the events and subsequent response to the incident that took place in the DFW datacenter on 29 June, 2009.

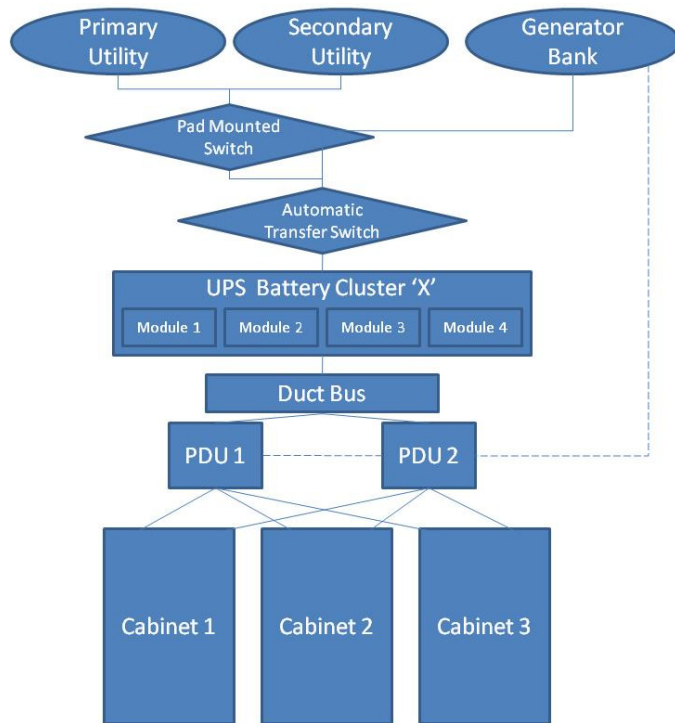
This data center infrastructure has been built with redundancy to allow for standard operation in the event of failed components.

- Rackspace can lose one utility feed and still be powered by generators or the other utility feeder (N+1)
- Rackspace can lose one generator in the generator bank and still power all three UPS clusters (N+1)
- Rackspace can lose one module in any individual UPS cluster and still power the attached PDUs and associated cabinets (N+1)
